## なら仏像館のリニューアルについて

## 岩田 茂樹

奈良国立博物館 上席研究員

## Renovation of the Nara Buddhist Sculpture Hall

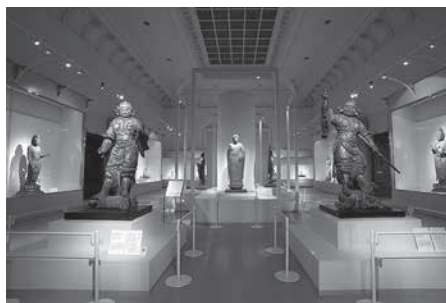
Fig. 2  
 なら仏像館第6室  
 平成23年(2011)4月  
 Nara Buddhist Sculpture Hall, Room 6, April 2011

つづいて平成23年（2011）4月、すなわち今回のリニューアルの5年前の状況を見よう（写真3）。前年の平成22年（2010）に旧本館を「なら仏像館」と改称し、同時にスポット照明の増設工事を行ったが、このときには既存の、彫刻のみではなく掛軸なども展示できる、高さがあって、かつ比較的奥行きが浅い展示ケースの上部から前方にアームを張り出させ、ここにスポットを取り付けられるダクトコンセントを仕込んだ。ただ作品に対して光線の角度がきつく、さらに光が充分な広がりをもつための距離もとれないため、作品の表面に多くの影が生じてしまうという問題が生じた。また少しでもスポット照明の効果を高めるため、天井の蛍光灯の光量を最小限としたため、展示室はかなり薄暗くなり、来館者から苦情の声が聞かれることとなった。

The next photograph shows an exhibition from April 2011 (Fig. 3), which was five years prior to the latest renovation. In 2010, the year before this photograph was taken, the Former Main Building was renamed the Nara Buddhist Sculpture Hall and additional spotlights were installed. Power ducts for the spotlights were installed where the arching arms extended from the tops of the existing high and relatively shallow display cases, which were suitable for exhibiting sculptures as well as hanging scrolls. The angle of illumination was too steep, however, and the spotlights could not be positioned far enough for the light to have enough spread. Consequently, the surfaces of the works were covered in shadows. Moreover, in an attempt to maximize the effect of the spotlights, the fluorescent ceiling lights were turned down, resulting

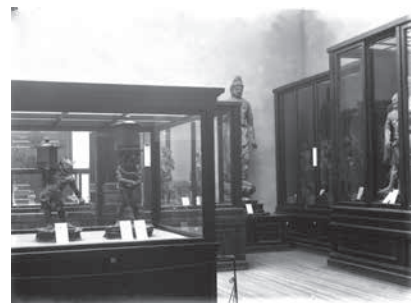
Fig. 3  
 奈良国立博物館第7室昭和20年代  
 (1945～54)頃  
 The Nara National Museum, Room 7, ca.1945-54

昭和20年代（1945～54）の展示風景を記録した写真（写真2）を見ると、奈良・元興寺と海龍王寺の五重小塔（重要文化財）や、奈良・秋篠寺の伝救脱菩薩立像（重要文化財）のような大きな作品は露出で展示されているが、その他の比較的小ぶりの作品は木製ガラスケース内に展示されている。大安寺四天王立像（重要文化財）や興福寺天燈鬼・竜燈鬼立像（国宝）のような、いずれも今は所蔵者のもとに返還された名品が陳列されているのが見えるが、この頃の展示方法はあまり制作年代やテーマ性などに拘らないおおらかなものであった。

In the photograph of an exhibition from 1945-1954 (Fig. 2), large works such as the five-storied pagodas of Gangōji temple and Kairyūji temple (Important Cultural Properties) as well as the Standing Gudatsu Bosatsu of Akishinodera temple in Nara prefecture (Important Cultural Property) were exhibited in an exposed state. Comparatively small artworks, however, were exhibited in cases made of wood and glass. This photograph shows masterpieces that have since been returned to their owners, including the Standing Shitenno of Daianji temple (Important Cultural Property) and the Tentoki and Ryutoki statues of Kōfukuji temple (National Treasures), and demonstrates that exhibitions at the time were rather loosely composed, with little regard to themes or chronology.

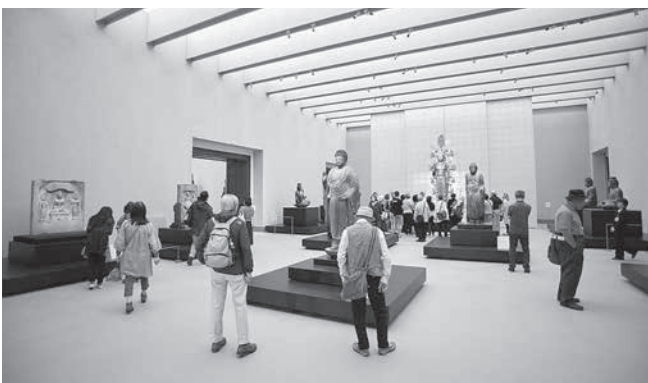
Fig. 4  
 なら仏像館第6室リニューアルオープン後  
 平成28年(2016)4月  
 Renovated Nara Buddhist Sculpture Hall, Room 6, April 2016

内壁の上面と、内壁と内壁とを繋ぐ梁の上面から、天井方向に向けてLEDスポット照明を点灯させ、これを躯体の天井にバウンスさせる間接照明により、室内の明るさを確保した。そして中央の第6・7・8室では梁の下面から、その他の小部屋では梁に直交するかたちで設けられたダクトコンセントから、露出およびガラスケース内の展示作品を照らした。用いた器具は、調光機能と照射角度を自在に調節できる機能をもつLEDスポットである (figs. 4・5)。

LED spotlights on top of the inner walls and beams were installed to point at the ceiling, with the light reflected off the ceiling for indirect illumination of the exhibition space. In Rooms 6, 7, and 8, which are in the center, the exposed works and those in the cases are illuminated via lights attached to the undersides of the beams. In the other, smaller rooms, the works are illuminated via lights attached to power ducts intersecting with the beams at right angles. These lights are LED spotlights with dimmers and adjustable focuses (Figs. 4 and 5).

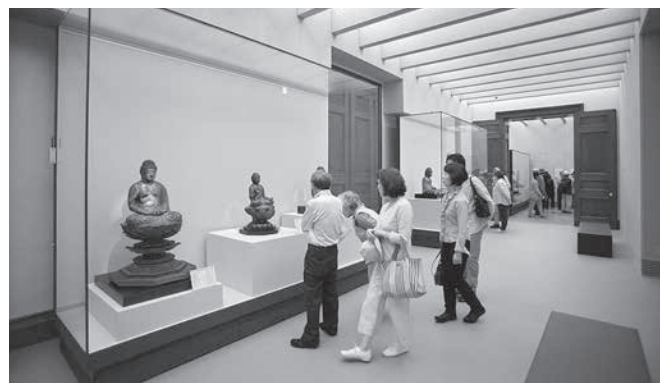
Fig. 5  
 なら仏像館第3室リニューアルオープン後  
 平成28年(2016)4月  
 Renovated Nara Buddhist Sculpture Hall, Room 3, April 2016
